Office of Risk Management

# Walk-Through

Audit Information		Audit Results	
Audit Type	Walk-Through	Score	N/A
Site Visit Date	7/17/2020	Status	N/A
LP Officer		No. of Recs	0
Participant

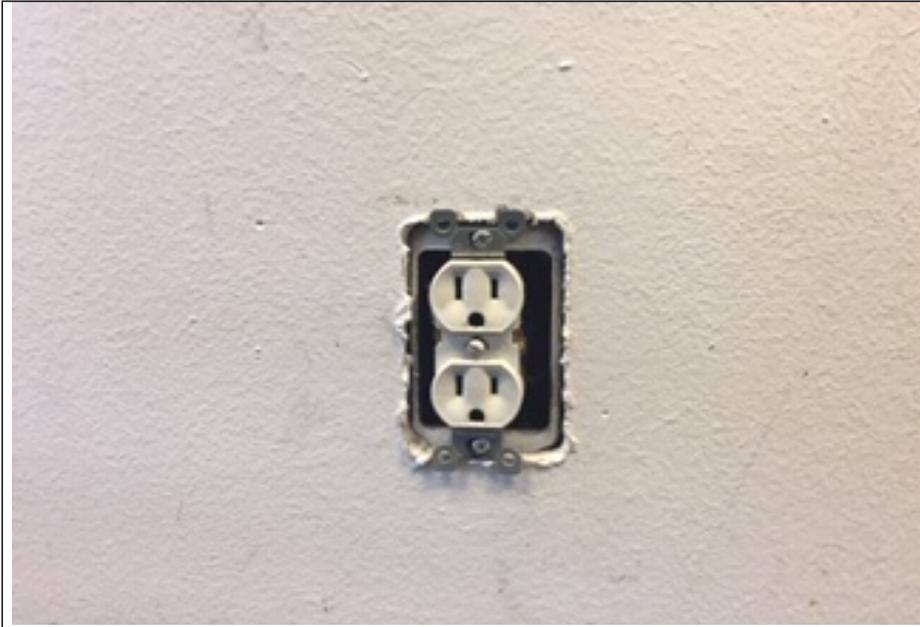
Question	Answer
Finding	The electrical socket located on the west wall of the waiting area is missing its cover plate.
Recommendation	Replace the missing cover plate on the electrical socket located on the west wall of the waiting area.

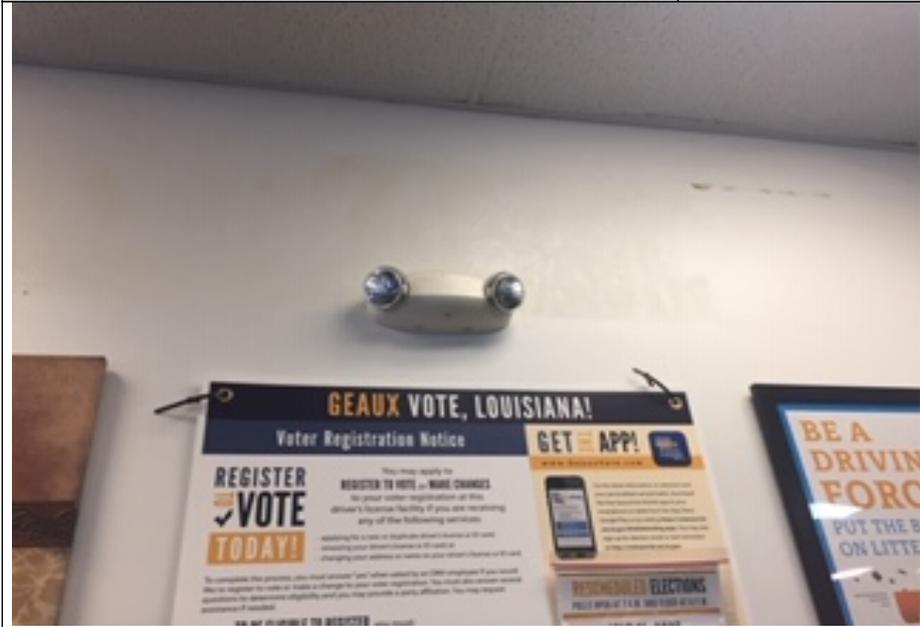
Finding	The emergency light located in the waiting area is not functioning.
Recommendation	Repair or replace the emergency light located in the waiting area.

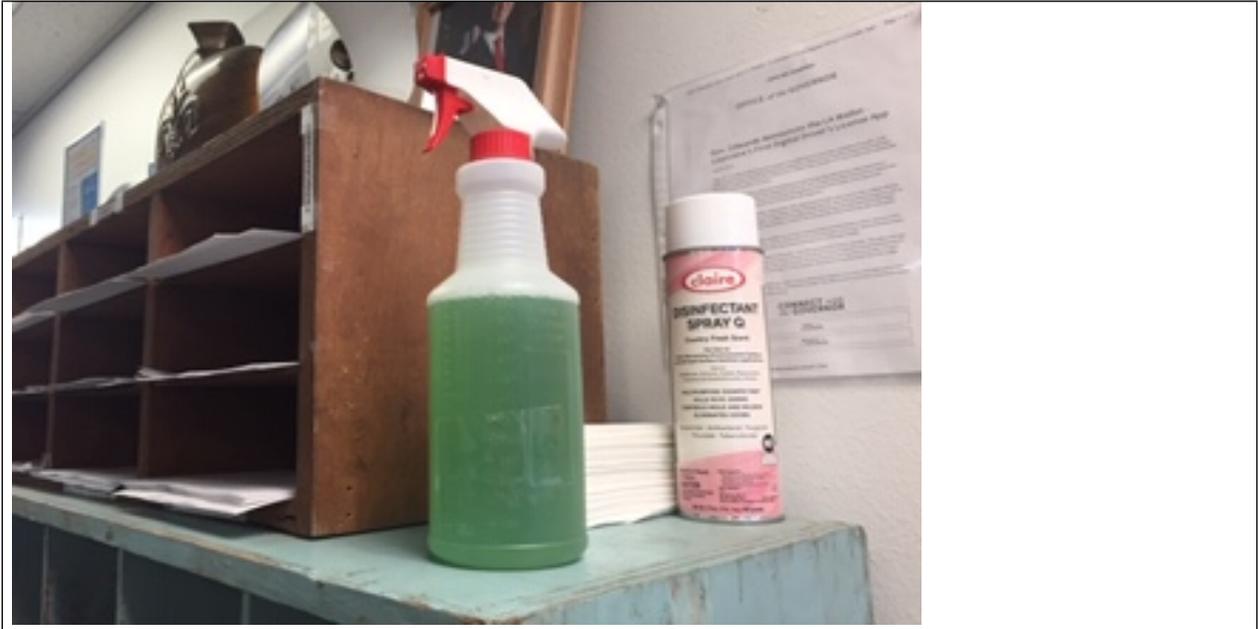
Finding	There was an unlabeled spray bottle located in the office area.
Recommendation	Properly label the spray bottle located in the office area.
